Technical Note N-1217

AIRFIELD PAVEMENT CONDITION SURVEY,
USNLF MONTEREY, CALIFORNIA

H. Tomita and L. J. Woloszynski

January 1972

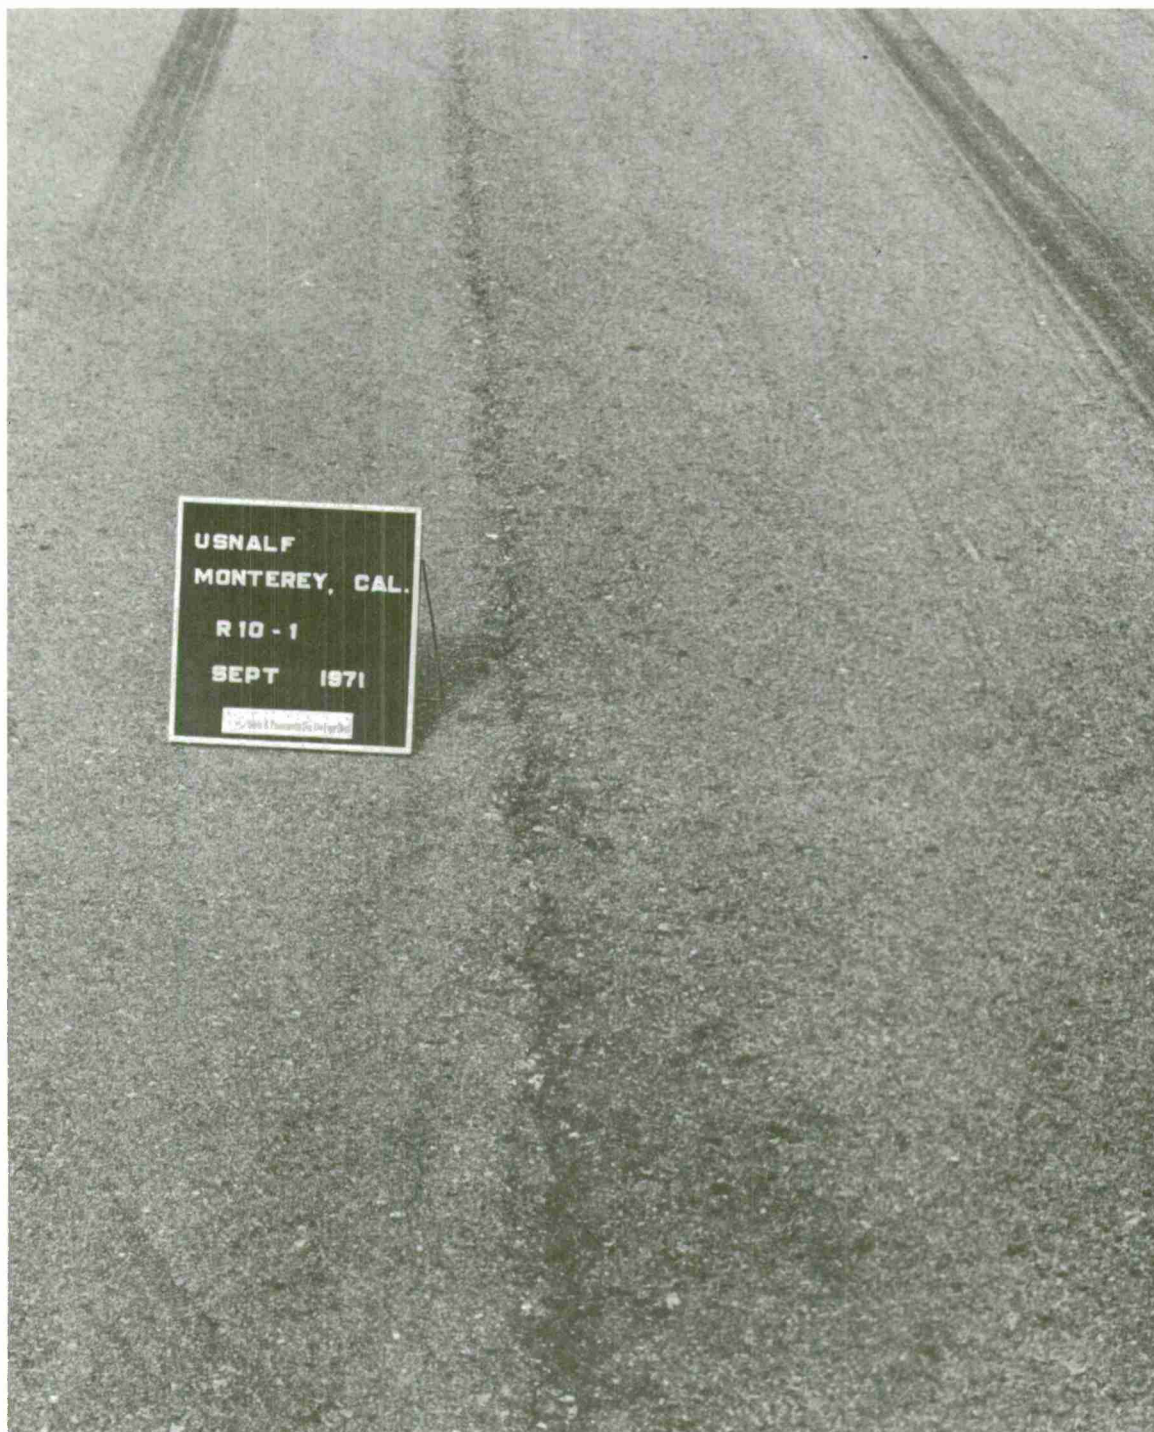
Figure 7. Longitudinal construction joint crack, Discrete Area R10-1.

Defect Type	Length or Area of Sampled Defects	Total Length or Area of All Defects: (c) x Ratio	Defect Density (per 10 sq. ft.) 10 d/a	Defect Severity Weight	Weighted Defect Density: (e) x (f)
	(c)	(d)	(e)	(f)	(g)
T.C., L.C. or LCJ*	590 ft	7,847 ft	0.157	3.0	0.471
Reflection Crack					
Faulting					
Patching					
Settlement or Depression					
Pattern Cracking	2,000 ft	26,600 ft ²	0.532	3.0	1.596
Rutting					
Raveling	6 ft	80 ft ²	0.002	7.0	0.014
Erosion—Jet Blast					
Oil Spillage					
Broken-up Area					
Total					2.08A
<p>Remarks on Pavement Condition</p> <p>Raveling occurred along longitudinal construction joints, and some loose material was observed. Most cracks were along longitudinal construction joints. Surface condition was smooth, and very little stripping was evident (see Figure 7).</p>

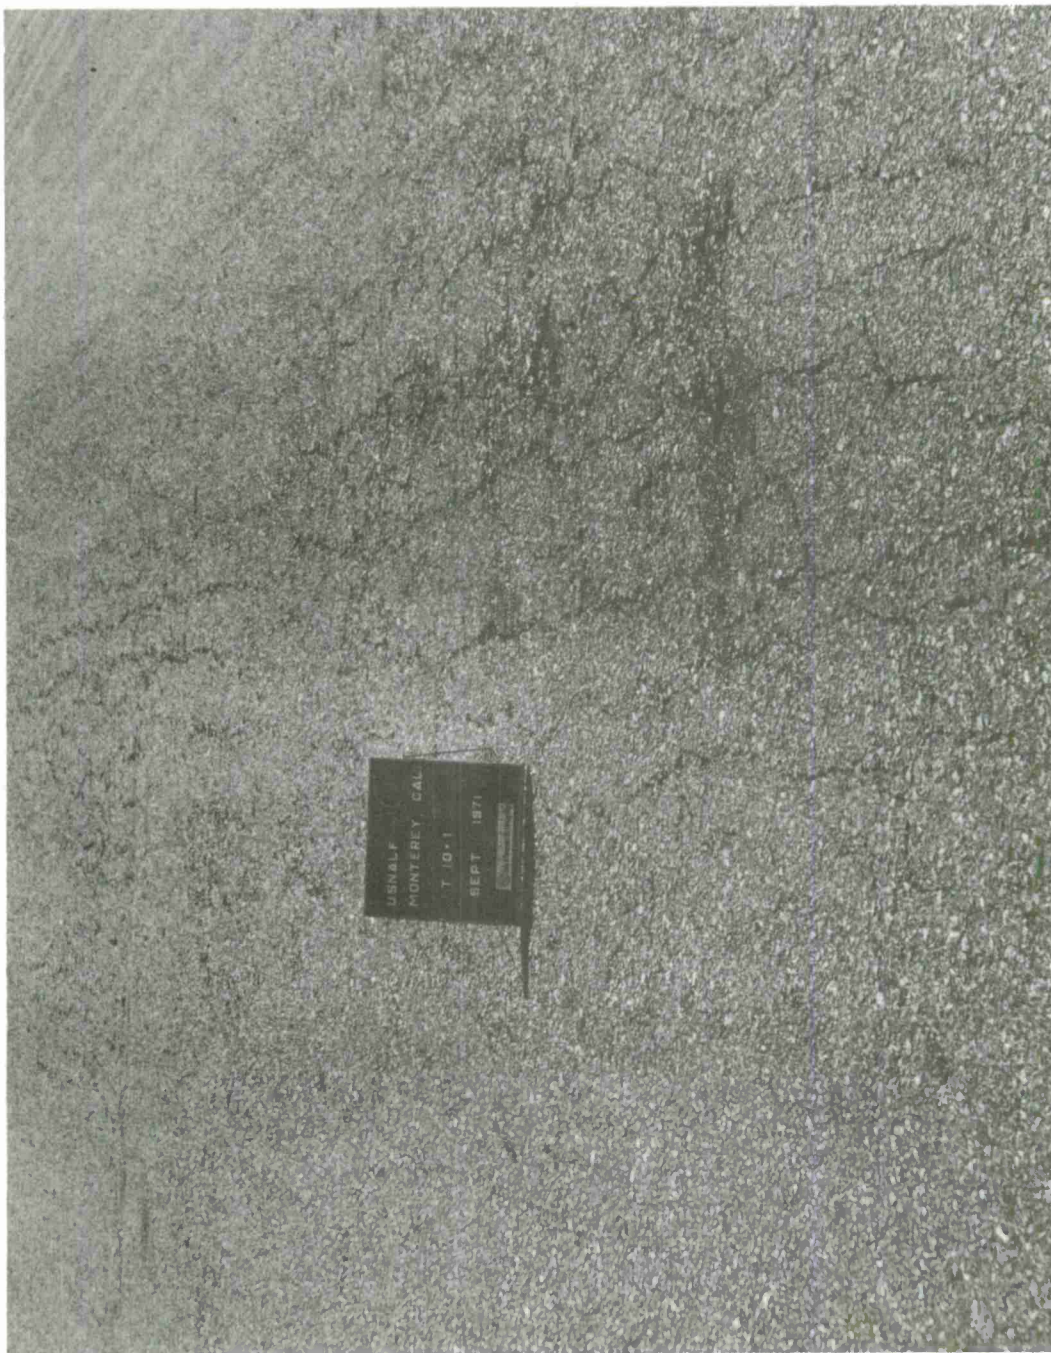
Figure 10. Pattern cracking, Discrete Area T10-1.

Defect Type	Length or Area of Sampled Defects	Total Length or Area of All Defects: (c) x Ratio	Defect Density (per 10 sq. ft.) 10 d/a	Defect Severity Weight	Weighted Defect Density: (e) x (f)
	(c)	(d)	(e)	(f)	(g)
T.C., L.C. or LCJ*	765 ft	4,590 ft	0.191	3.0	0.573
Reflection Crack					
Faulting					
Patching	100 ft ²	600 ft ²	0.025	3.0	0.075
Settlement or Depression					
Pattern Cracking	11,690 ft ²	70,140 ft ²	2.914	3.0	8.742
Rutting					
Reveling	12 ft ²	72 ft ²	0.003	7.0	0.021
Erosion-Jet Blast					
Oil Spillage					
Broken-up Area	350 ft ²	2,100 ft ²	0.087	9.0	0.783
Total					10.19A
Remarks on Pavement Condition					
Pattern cracking was a combination of shrinkage and dendritic types forming polygons with 6" to 2' sides. Approximately 3/4 of the surface aggregate was stripped of bitumen (see Figure 10).
